Application Case Study

| Application:Cleaning and Part Marking System for Manufacturing CellDate:11/19/20 | | | |
| Serial number: | 970-0220, | Machine model: Aquamaster CB-800E (both machines) | |

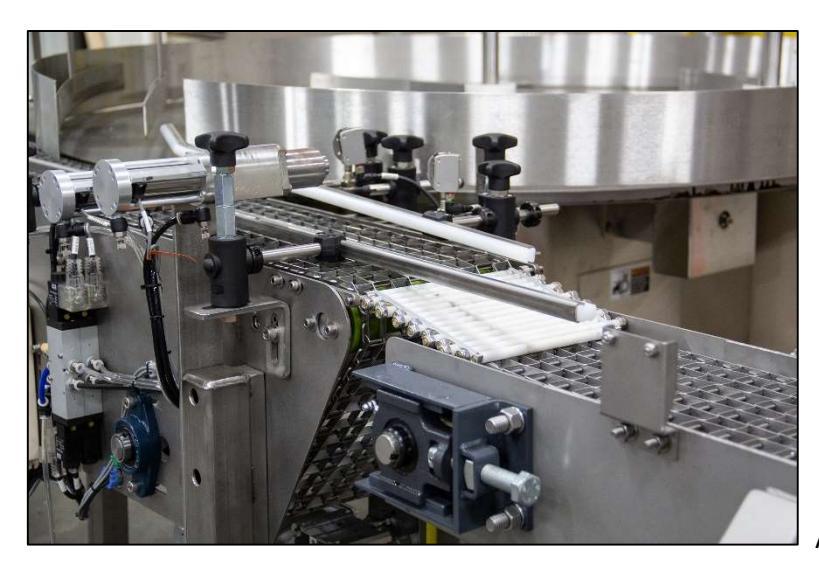
Accumulating table – Machine #1

Alliance provided two Aquamaster CB-800E machines for the customer's manufacturing cell, to be used both before and after parts go through a heat induction system. The parts first are manually placed onto a rotary accumulating conveyor on the load end of machine #1 and are released at timed intervals into the wash zone. Machine #1 utilizes a heated blow-off so that the parts are completely dry before exiting. At the end of the conveyor on machine #1, a pneumatic transfer device pushes the part onto a small table where it is rotated and scanned for verification. Parts are then picked and placed by a robot onto the customer-supplied heat induction system within the manufacturing cell. Upon completion, a robot again picks the parts and places them onto the conveyor of machine #2. Before entering the wash zone, parts are stopped by a pneumatic device and marked for identification. Parts then go through a wash and ambient blow-off. Finally, parts are again pushed onto a rotary table to be scanned for verification at the end of washer #2.

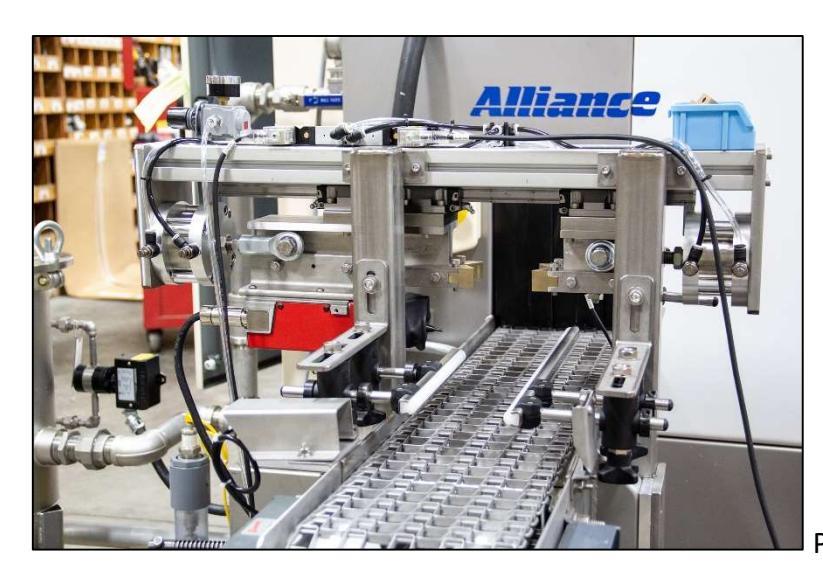
Part marking device – Machine #2
