Application Case Study

Application: Cleaning Refurbished Turbo Housings					Date:	3/16/23
Serial number: 1042-1221 Machi			del: CB-30	000E		
Machine type: Co	onveyorized Belt		Industry:	Electroni	cs/Electri	cal

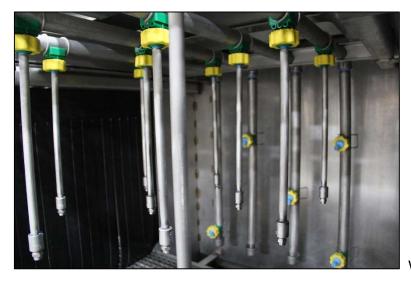
Wash zone with extended spray nozzles

Alliance provided a conveyor belt washer with wash, rinse, and ambient blow-off zones. A mist collector was added for returning condensation back into the tank to conserve water. An oil coalescer was also added to remove large quantities of oil from the solution tank, and microfiltration system was added to both the wash and rinse zones to clear the solution of small contaminants. Extended spray nozzles were used to reach the low-profile parts and are removable for future applications cleaning taller parts.

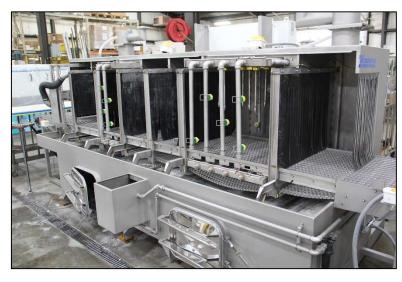
Canopies removed to show interior
